Evaluation of an Incident Involving a Black Iron Pipe Gas Fuel Distribution System

Report Date: February 22, 2013
RTI Matter No.: 50181ME010
RTI Matter Name: Cole v. Omega Flex

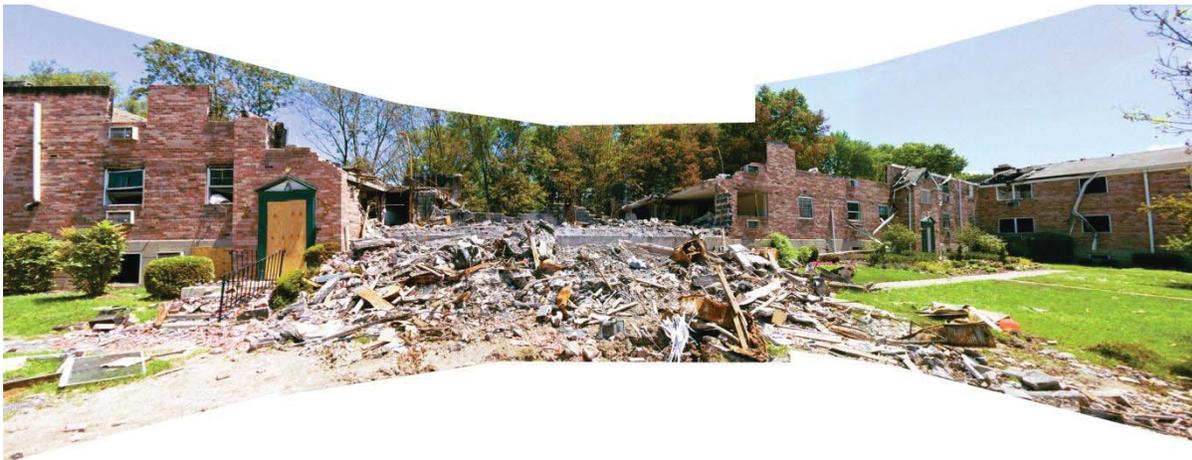
Figure 2. View of the front of building A – composite of several photographs.

The explosion that occurred on June 16, 2001 was the result of liberated and fugitive natural gas having accumulated over a significant period of time within sections of Building A, and having been ignited by some competent ignition source. The ensuing explosion caused massive property damage, as seen in **Figures 1, 2 and 3**, as well as personal injuries and several fatalities. In short, the release of fuel gas resulted in a catastrophe.

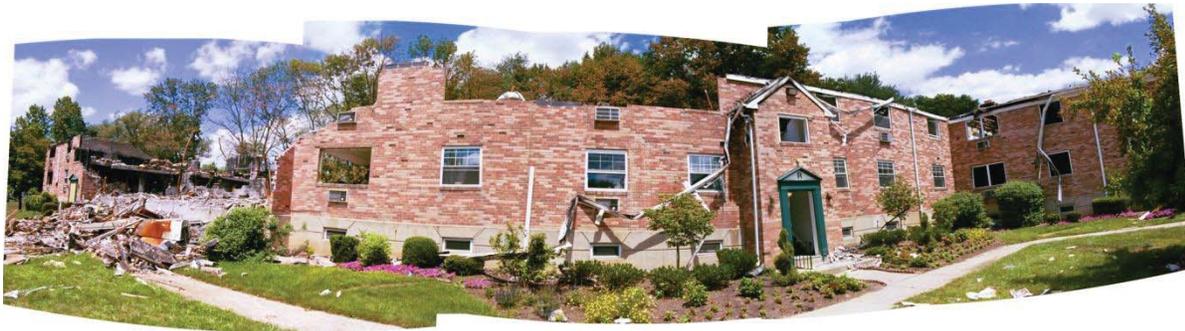
Figure 3. View of front of building B – composite of several photographs.

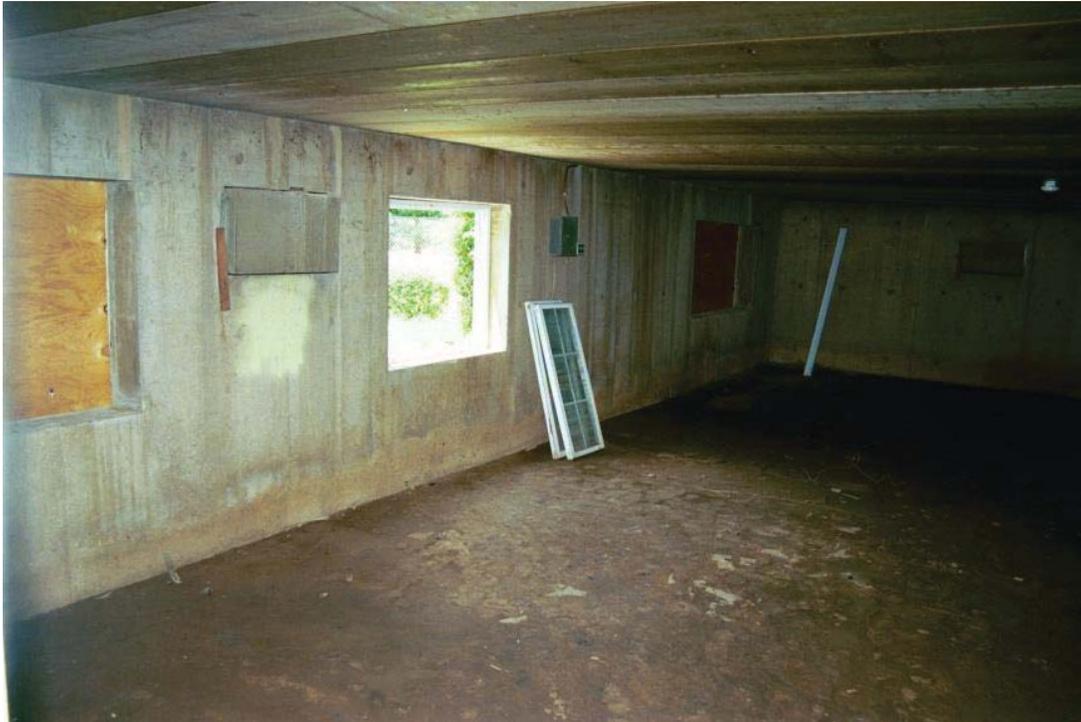
There were several windows to the basement that varied in size. As seen in **Figure 4**, the larger windows extended below the basement wall mid-height. The larger windows were missing their glass. Some of the smaller windows exhibited signs of exposure to outside pressure as they were deformed around their frames; however, the glass on the smaller windows was still present in the frames. On the first and second level were four units on each level. On one side of the common way were two-bedroom units; on the other side were one-bedroom units. The attic was unoccupied.

Figure 4. View from the northern front basement room in building A. Note the two sizes of windows, the larger window having failed during the storm.

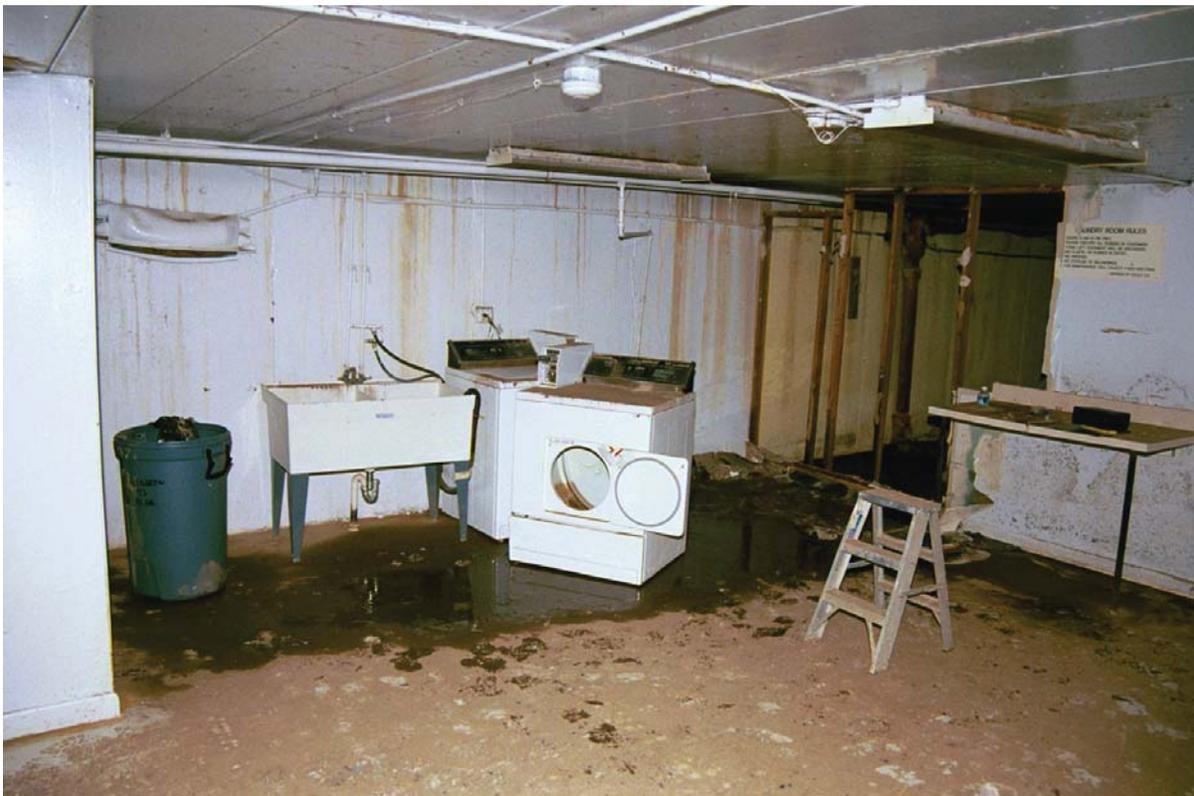
The laundry room in building A was found to have a mop sink, electric washer, a gas-fired dryer, and a folding table, as seen in **Figure 5**. A section of the wall between the gas dryer and the folding table had failed. The dryer was displaced and rotated from the wall. The mop sink, washer, and folding table remained in, or close to their original locations. Brown silt was found within the fluorescent light fixtures, indicating the room had at one time been completely submerged. The ceiling comprised of the reinforced concrete hollow planks, had seams with approximately 1/8- to 1/4-inch gaps.

Figure 5. View of laundry room in building A.

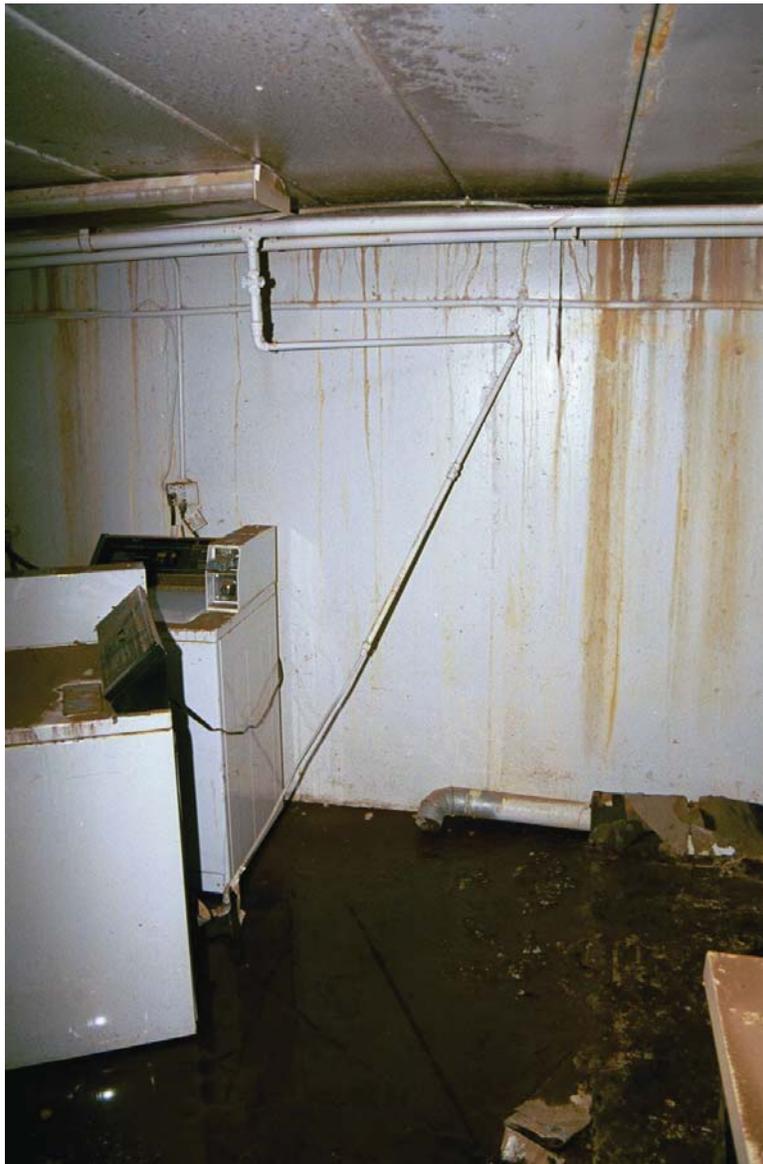
Figure 6. View of upper elbow and gas pipe break.

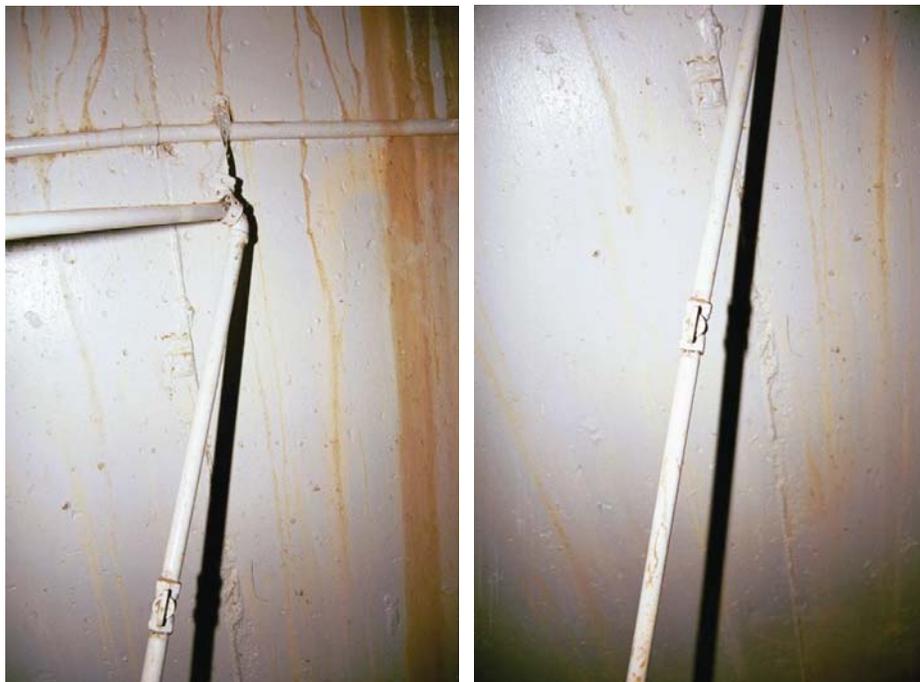
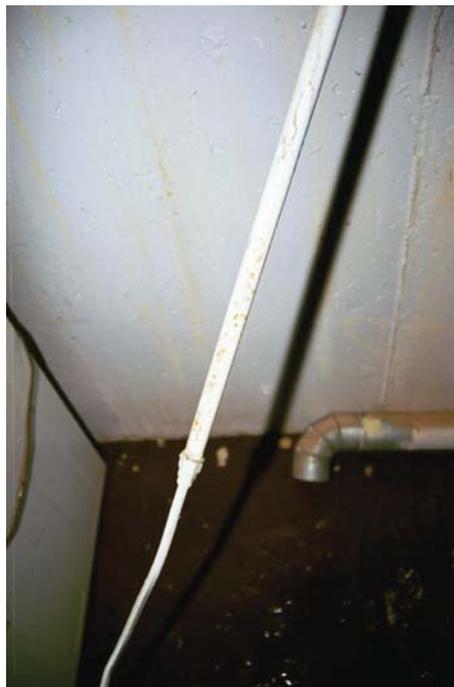
The natural gas fuel for the dryer was fed from a black iron pipe tee tap in the fuel gas main running across the basement ceiling. A 1-inch line dropped from the tee tap about 12 inches, turned 90° horizontally to the right and towards the wall (facing the wall) through a 1-inch to 3/4-inch reducer and a 90° elbow to a 3/4-inch line (**Figure 6**). The 3/4-inch line ran horizontally towards the wall for about 36 inches, turned 90° downwards through a street elbow (**Figure 7a**). The 3/4-inch line ran about 45 inches, through a shut-off valve (**Figure 7b**), to a fitting for the 1/2-inch corrugated steel flexible pipe line (**Figure 7c**). The flexible line was approximately 36 inches in length, and terminated into a 3/4-inch 90° iron pipe elbow fitted to a 3/4-inch black iron pipe stub 6 inches in length coming off the back of the dryer (**Figure 8**).

Figure 7. Closer view of subject pipe line.

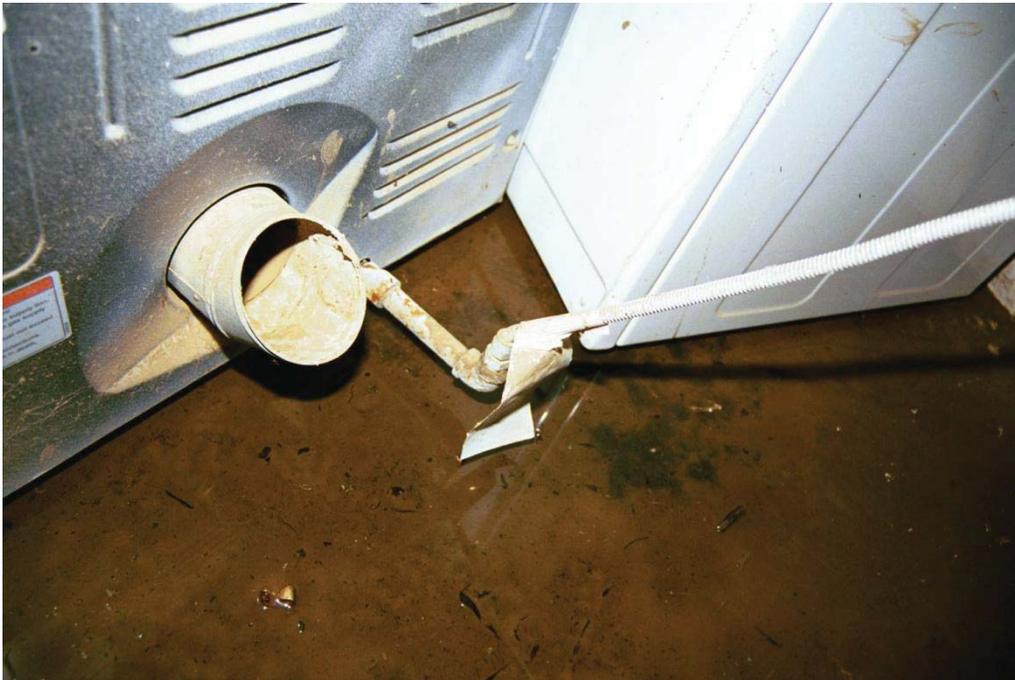
Figure 8. View of corrugated steel flexible line connecting to stub on dryer.

6. The flexible connector present on the subject dryer was intact at the time of the inspection, and provides insight as to the survivability of a CSST based system under the adverse conditions encountered during the flood.

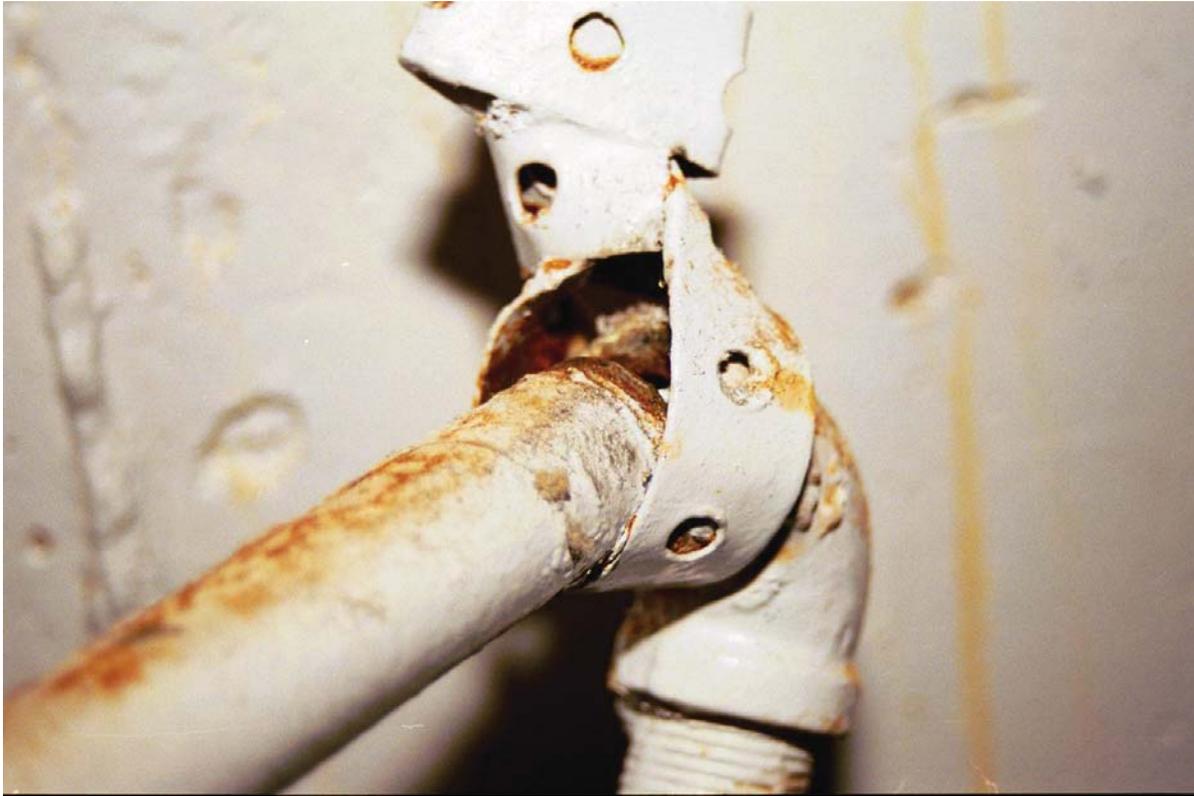
The black iron pipe above the dryer had failed at the 3/4-inch 90° street elbow near the ceiling. It was specifically the black iron pipe section, not the elbow fitting, which failed at the thread fitting outside the upstream side of the elbow, as seen in **Figure 9**. There was no evidence to show that there ever was a pipe anchor used to secure the vertically running section of black iron pipe to the wall. Additionally, the dryer was not secured by tracks or any other means. The only method used to secure the vertical run of black iron pipe was a pipe strap fixed to a section of electrical conduit near the elbow. The area of the black iron pipe break opening exceeded the pipe flow cross sectional area, allowing unrestricted release of fuel gas into the laundry room after the failure.

Figure 9. Close view of failure site and hanger.

The release of fuel gas was due to a breach of a section of black iron pipe that was subjected to inappropriate loading forces from the displacement of an appliance affected by a severe natural event. The displacement of the appliance induced a stress on the black iron pipe causing the pipe to fail. Had the fuel gas distribution system been constructed from CSST rather than black iron pipe, the displacement of the dryer would likely not have caused a fracture and breach in the distribution system, the fuel gas would not have been liberated, and the explosion would not have occurred. The flexibility of CSST would have allowed the fuel gas distribution system to have tolerated the large displacement of the appliance. The conclusion that a CSST line would have survived this event is demonstrated by the fact that the flexible gas appliance connection tubing, a product similar to CSST, between the subject appliance and the black iron pipe distribution system remained intact and connected after the flooding and explosion.

The fracture of the black iron pipe was clearly due to several factors: the area had been affected by a tropical storm causing the local creek to rise and flood the apartments; the flooding into the basement had displaced the unsecured dryer; and the black iron pipe was not properly secured with wall anchors, allowing free range of motion of a distribution system not designed for such displacements.

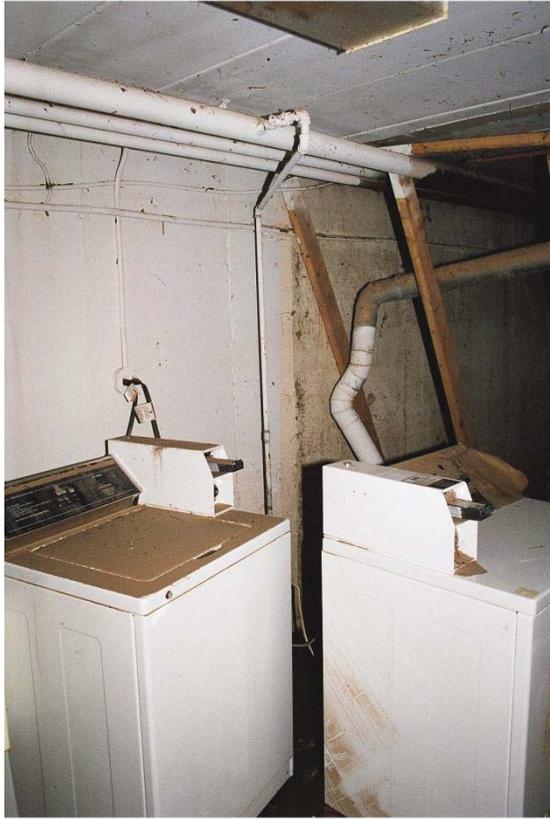
The laundry rooms of buildings B and C were inspected to discover the method used for securing the dryer gas pipe. Although these buildings' basements were also flooded, there were no reported gas leaks. The dryer in one building was also displaced, and the adjacent wall also suffered damage; however, the pipe was intact despite the lack of a pipe anchor on the vertical run (**Figure 10**). The laundry room of another basement revealed that the dryer had been slightly displaced (**Figure 11**). The pipe servicing the dryer in this building did have a single pipe anchor on the vertical run and remained undisturbed. In all cases, the flexible corrugated steel tube connecting the dryers to the black iron pipe distribution system remained intact.

Figure 10. Dryer gas pipe without anchors.

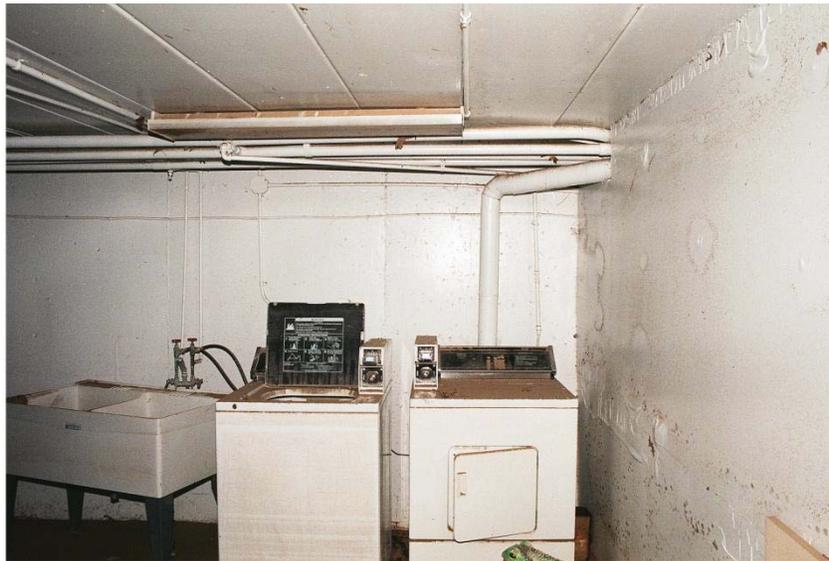
Figure 11. Laundry room in building where the gas pipe was anchored.
