**RTI Group, LLC**  
910 Bestgate Road, Suite E  
Annapolis, MD 21401  
ofc: +1 410 571 0712 | fax: +1 410 571 0713  
[www.rtiForensics.com](http://www.rtiForensics.com)

# CSST Test Report

**Report Date: April 19, 2013**

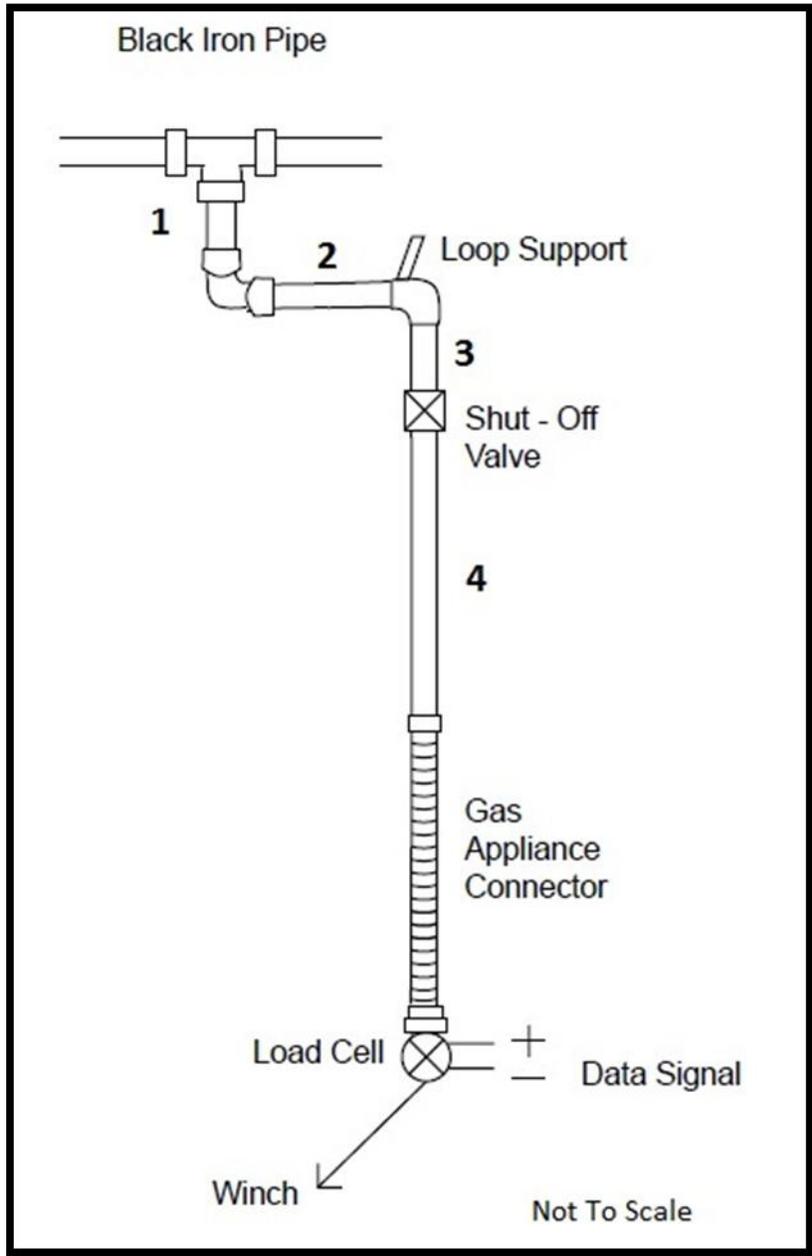
Figure 1. Installation diagram for the Black Iron Pipe System

1. 2-inch black iron tee
2. 1-inch diameter pipe, 12 inches in length, member 1
3. 1-inch to  $\frac{3}{4}$ -inch reducer
4.  $\frac{3}{4}$ -inch 90 degree elbow
5.  $\frac{3}{4}$ -inch diameter pipe, 36 inches in length, member 2
6.  $\frac{3}{4}$ -inch 90 degree street elbow
7.  $\frac{3}{4}$ -inch diameter pipe, 18 inches in length, member 3
8.  $\frac{3}{4}$ -inch shut off valve
9.  $\frac{3}{4}$ -inch diameter pipe, 25 inches in length, member 4
10.  $\frac{3}{4}$ -inch to 1-inch coupler
11. 1-inch to  $\frac{1}{2}$ -inch reducer
12.  $\frac{1}{2}$ -inch diameter GAC gas line, 36 inches in length
13.  $\frac{3}{4}$ -inch tee
14. Steel Pipe strap loop support

The BIP system was constructed according to **Figure 1**.

The BIP setups were tested using the configuration found in **Figure 1** where the BIP terminated into a GAC that was not anchored to the wall. Each CSST product was tested as seen in **Figure 2** with the GAC attached. Each CSST product was subsequently tested without the GAC attached. Once each piping system was assembled and secured to the test platform, the following procedures were followed for testing:

Four sets of the BIP were tested. All four tests resulted in the BIP pipe section failing at the threads where the pipe entered the elbow fitting between members 2 and 3 (see Figure 1). Twice the tests resulted in the threads on member 2 failing while twice the failures happened in the threads on member 3. The failures occurred when an average of 115 lbs was applied to the end of the GAC. Detailed data can be found in Appendix 1 where the loads are plotted with respect to time.

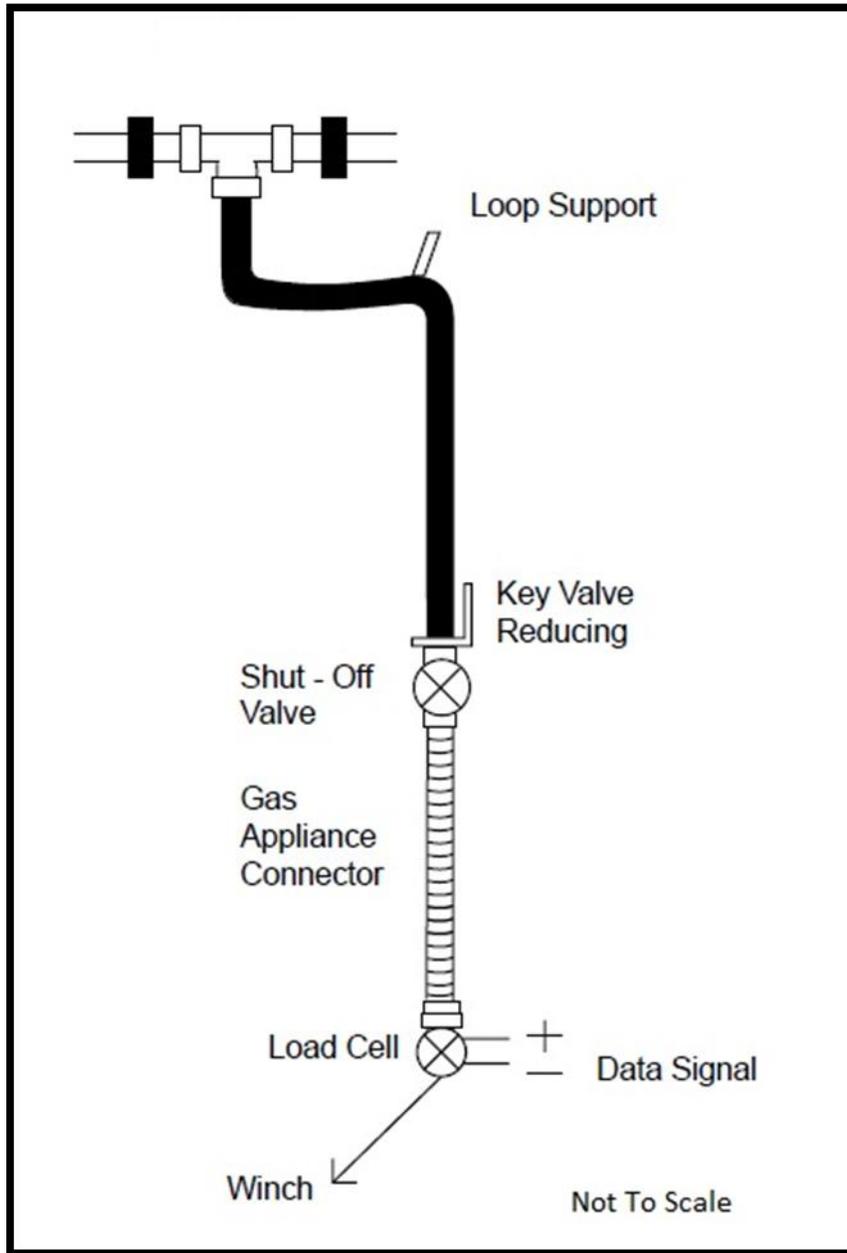
Figure 2. Installation diagram for CSST System.

1. Tee reducer, 2 inch by 2 inch by  $\frac{3}{4}$  inch
2.  $\frac{3}{4}$ -inch diameter, 8 feet in length CSST
3.  $\frac{3}{4}$ -inch to  $\frac{1}{2}$ -inch reducing key valve,
4.  $\frac{1}{2}$ -inch shut off valve
5.  $\frac{1}{2}$ -inch diameter Gas Appliance Connector (GAC), 36 inches in length
6.  $\frac{3}{4}$ -inch tee
7. Steel pipe strap loop support

The CSST Systems were both constructed according to **Figure 2**.

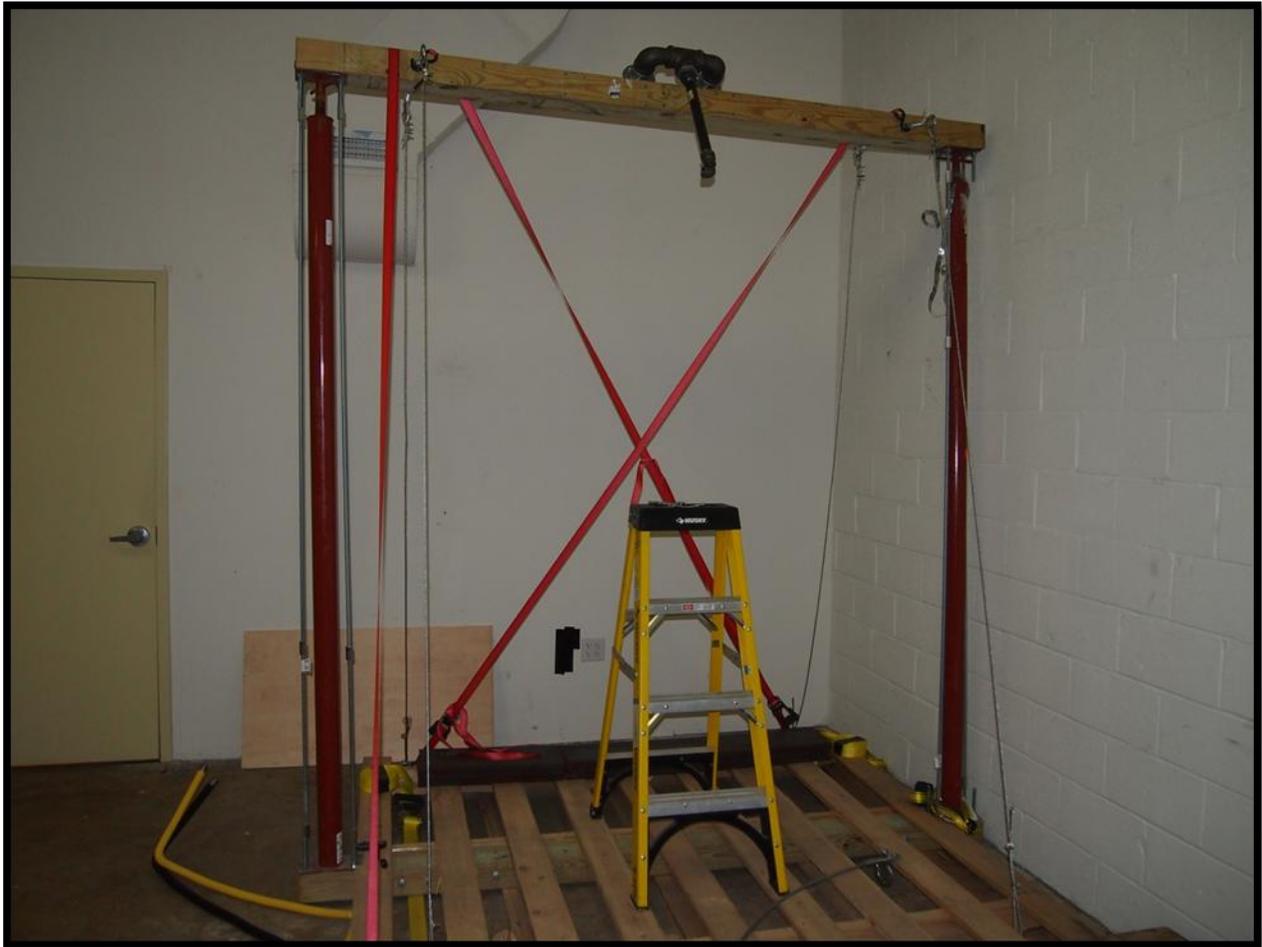
Figure 3. Piping system testing platform

A testing platform was constructed to provide the structure to which the gas fuel distribution systems would be attached and to approximately replicate the anchoring used in the Village Green Apartments. The platform consisted of a rectangular wood and steel frame secured by weights, as seen in **Figure 3**. Attached on the opposite end of the base was a 12,000 lbs rated winch with the tension force applied at 45° from the normal of the plane presented by the frame. The angle was selected to best represent the direction of displacement by the dryer in the Village Green Apartments basement at the time of the incident.

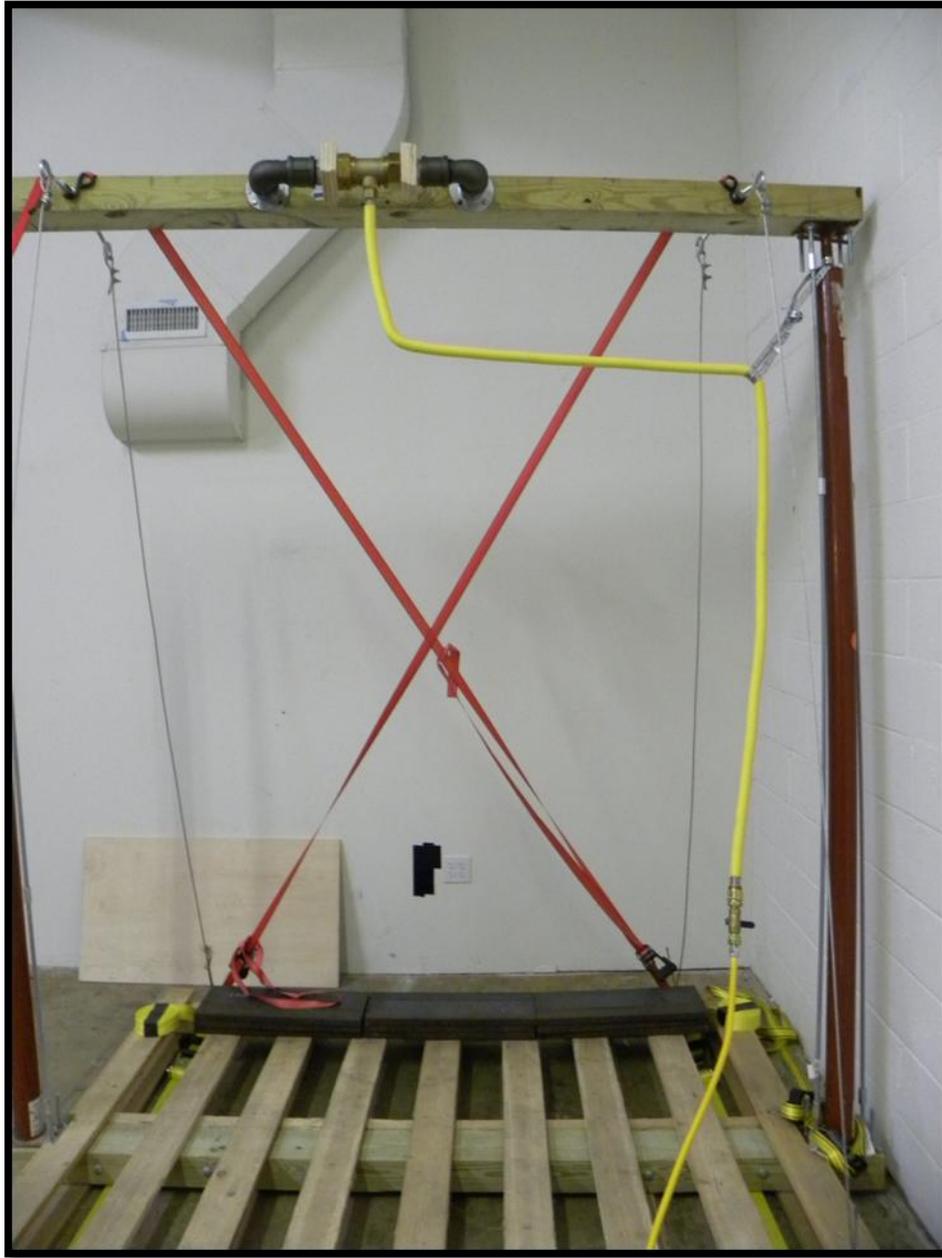
Figure 4. TracPipe installation as tested with the GAC.

Two tests were performed on each of the CSST sections: one with the GAC and one without. The CSST was configured approximately as the BIP, as seen in **Figures 4 and 5**. The steel strap at the top bend was wrapped around the CSST and the connection with the GAC was left unanchored. None of the CSST systems failed when subjected to similar loading as the BIP systems.

The testing demonstrated that both CSST systems would withstand greater loads than the BIP system when stressed in a like manner. With the GAC attached, the maximum load achieved by TracPipe test was 218 lbs. and CounterStrike test achieved 211 lbs., both without failure or loss of gastight integrity. The testing was stopped because there was no more space available between the rack and the winch to continue displacing the CSST section, and the measured loads well exceeded the failure loads of the BIP sections. The metal strap deformed the exterior

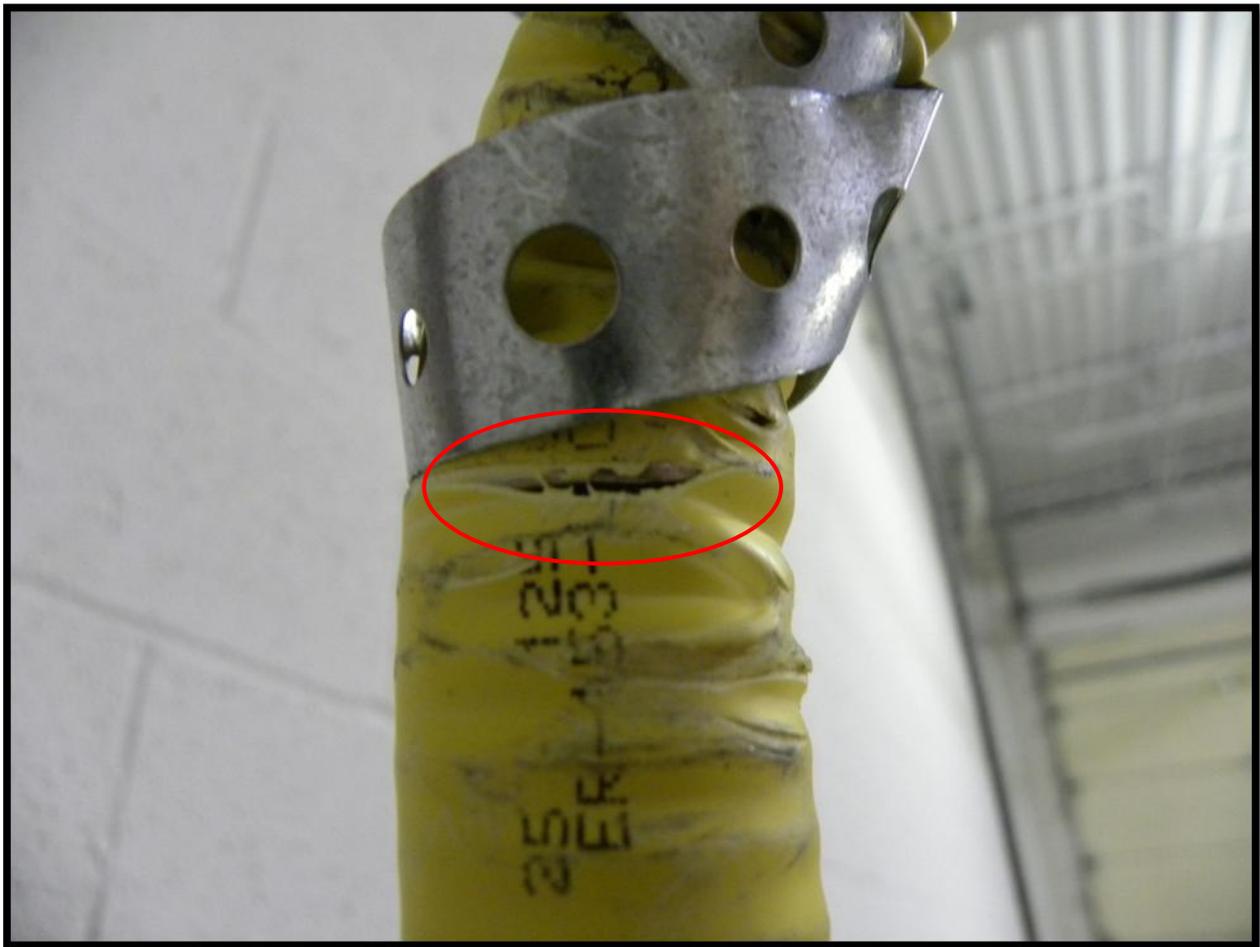
Figure 6. A perforation in the insulation resulting from the use of metal pipe straps

It was noted that during the tests without the GAC, the metal pipe straps cut into the insulation of the TracPipe and deformed the insulation of the CounterStrike (**Figures 6 and 7**). However, the integrity of the internal tubing was maintained; the interaction of the metal strap with the CSST never resulted in a gas leak. Detailed load data can be found in Appendix 3.

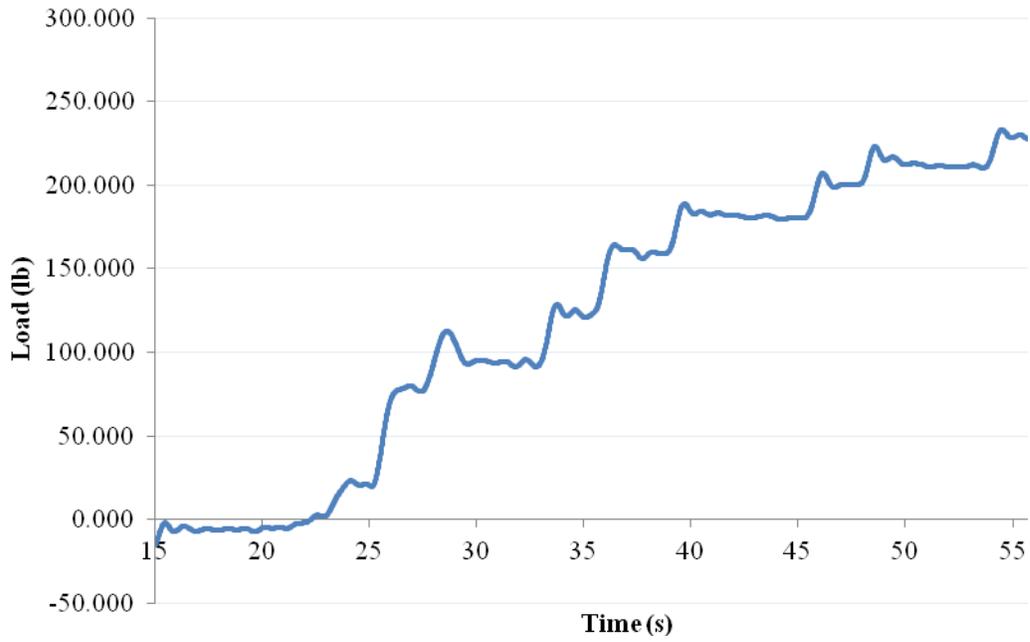
**Tracpipe Test 1, no GAC**

In a subsequent test with the GAC removed, the TracPipe test was tensioned to a maximum measured load of 250 lbs while the CounterStrike test achieved a measured load of 282 lbs without failure or loss of gas tight integrity. The tests were stopped because the measured loads had exceeded the protocol limit of 250 lbs.
