Evaluation of an Incident Involving a Black Iron Pipe Gas Fuel Distribution System

Report Date: February 22, 2013
RTI Matter No.: 50181ME010
RTI Matter Name: Cole v. Omega Flex

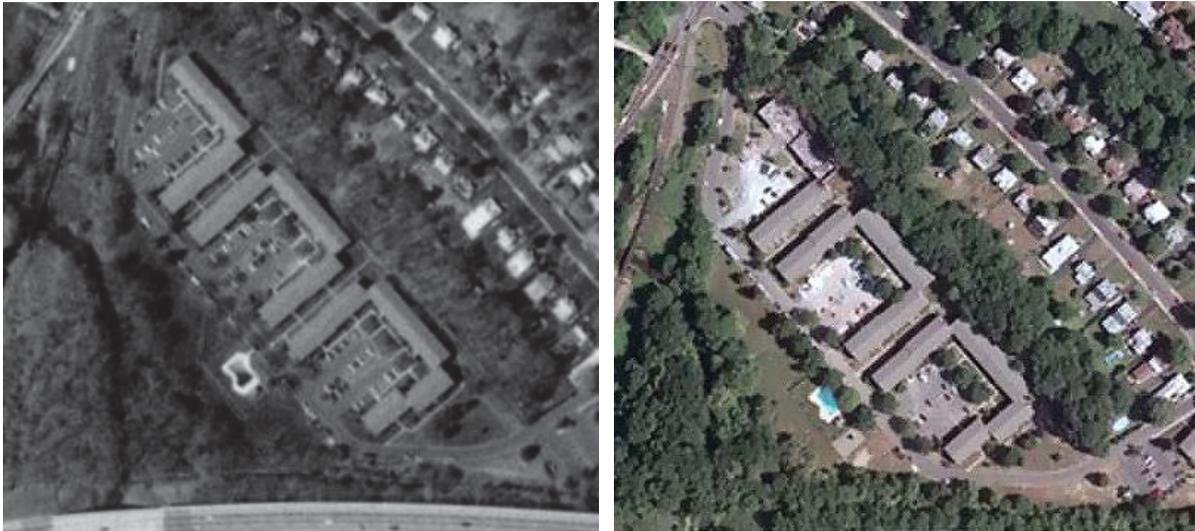
Figure 1. Aerial view of Village Green Apartments complex, April 24, 1999 and July 16, 2001.
Note: Images are oriented with north to the top.
